UNDERWATER BRIDGE INSPECTION REPORT

STRUCTURE NO. 94246

MISSISSIPPI RIVER

DISTRICT 5 - HENNEPIN COUNTY, CITY OF MINNEAPOLIS

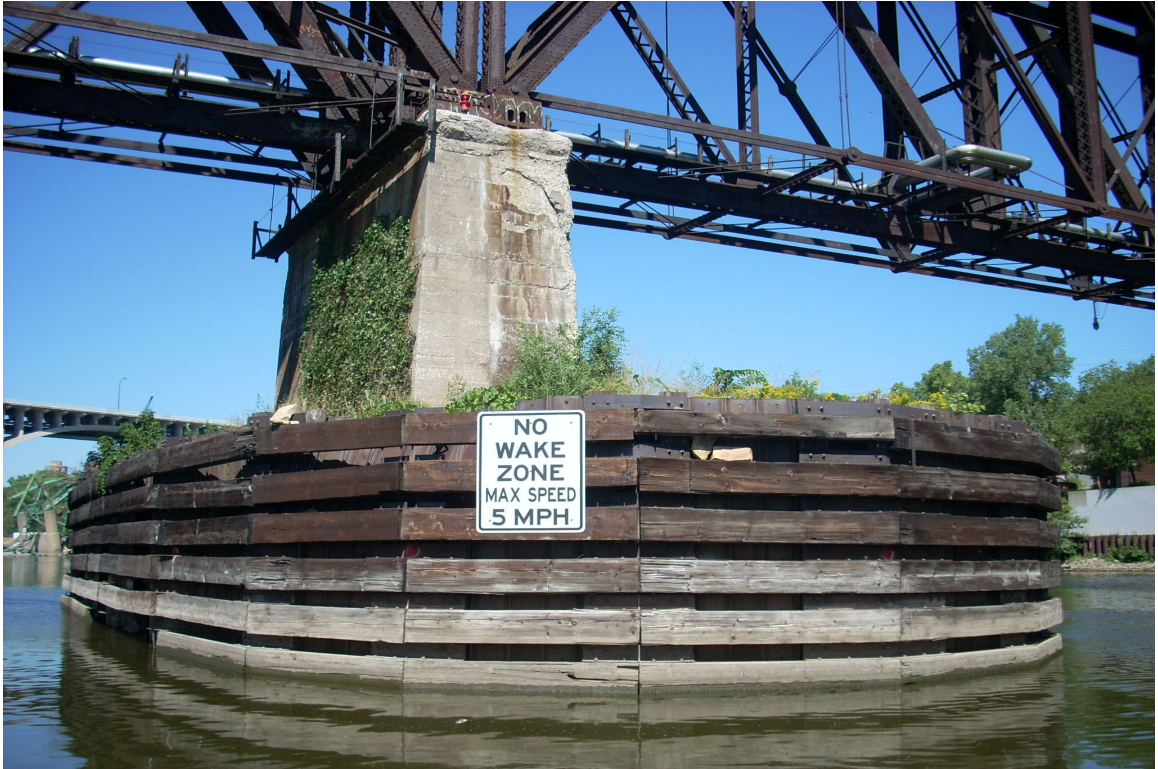
Photograph 1. View of Downstream End of Pier 4, Looking North.

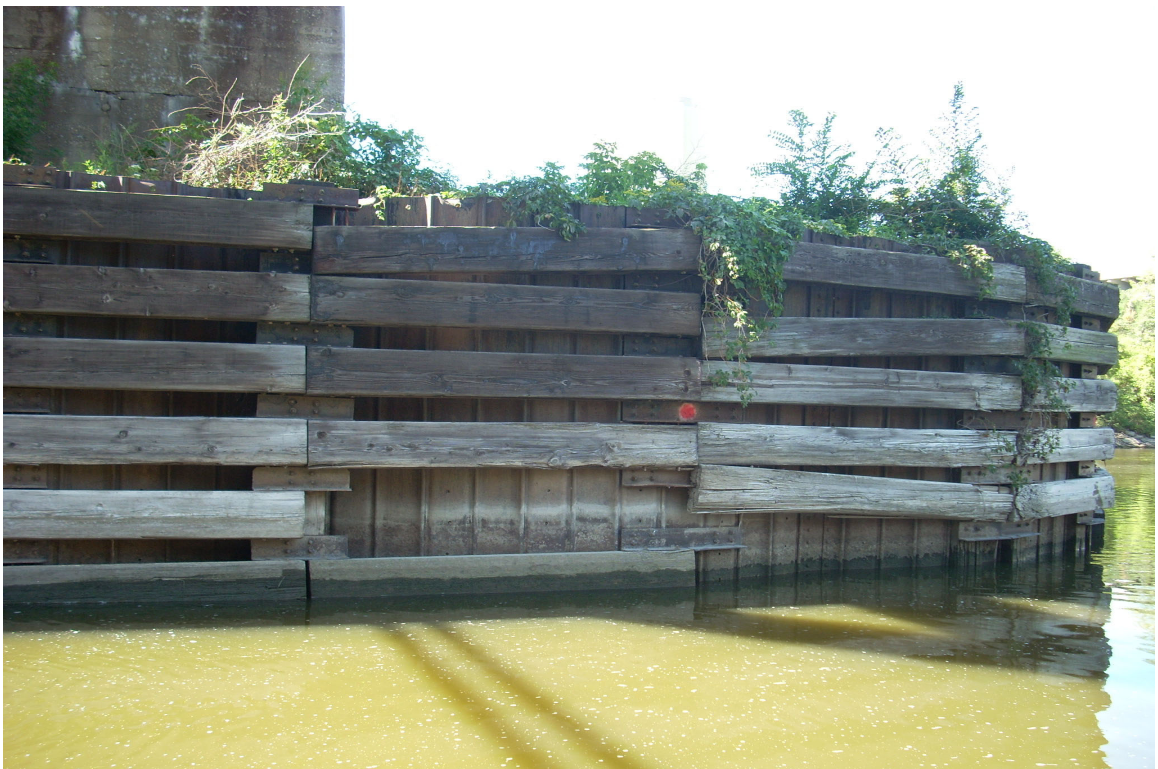
Photograph 2. View of Damaged Fender System at Upstream Half of Pier 4, Looking West.

- 4 Fender system timber whalers were in fair to poor condition with some areas of decay and rot at the waterline and several failed connections. Moderate impact damage was evident in several locations around the pier perimeter. (See Fender Damage Plan).

* Depending on the proposed future use of the structure, consideration can be given to replacing the missing, deteriorated and damaged timber fender components during normal maintenance operations.

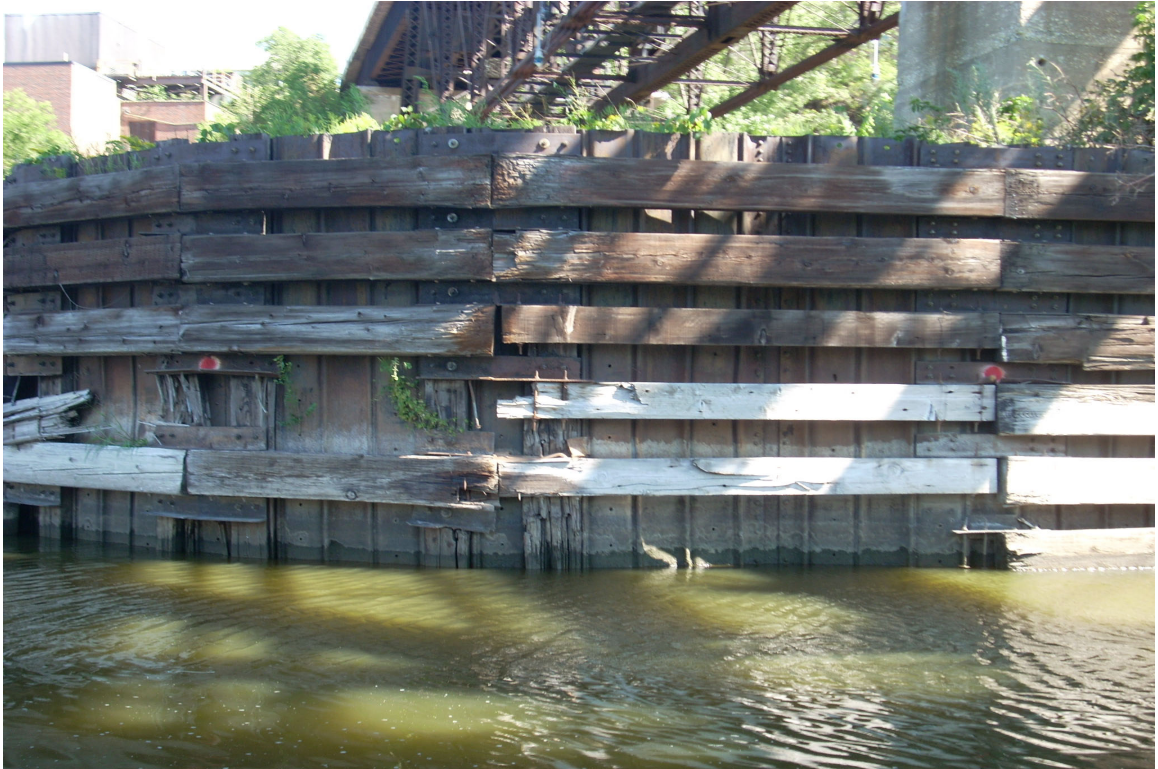
Photograph 3. View of the Damaged Fender System at Upstream Nose of Pier 4, Looking East.

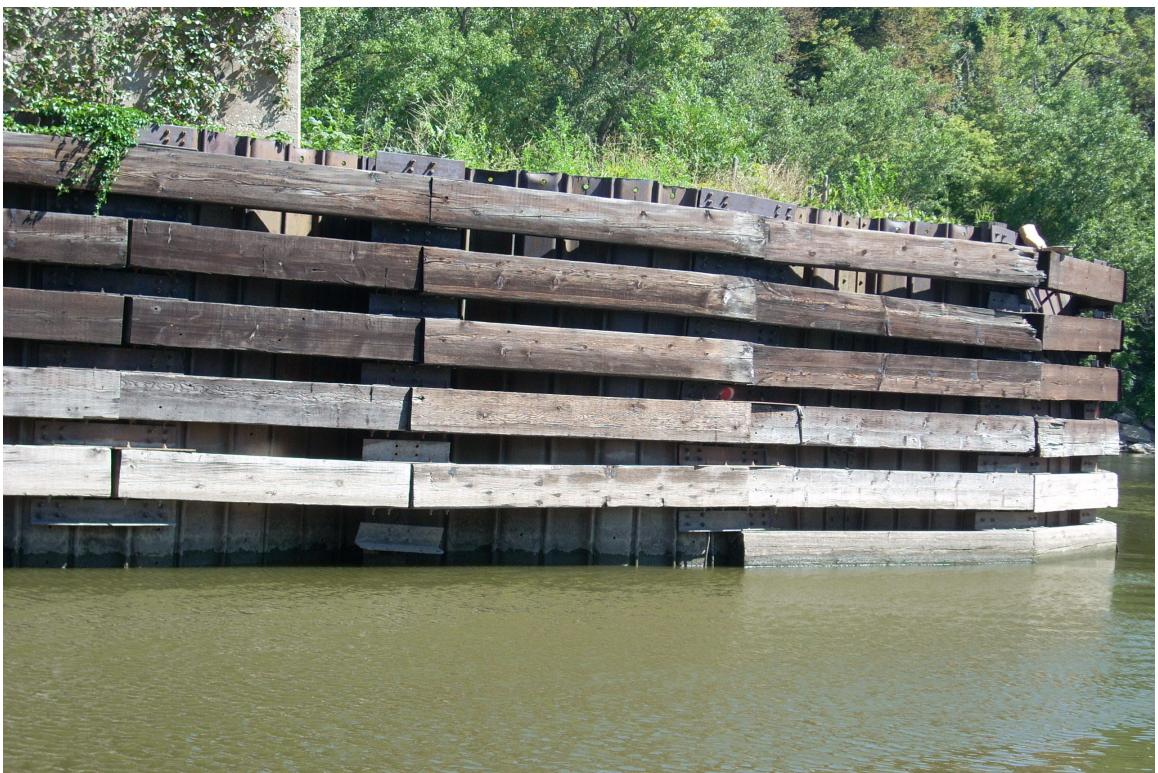
Photograph 4. View of the Damaged Fender System at Downstream Half of Pier 4, Looking East.

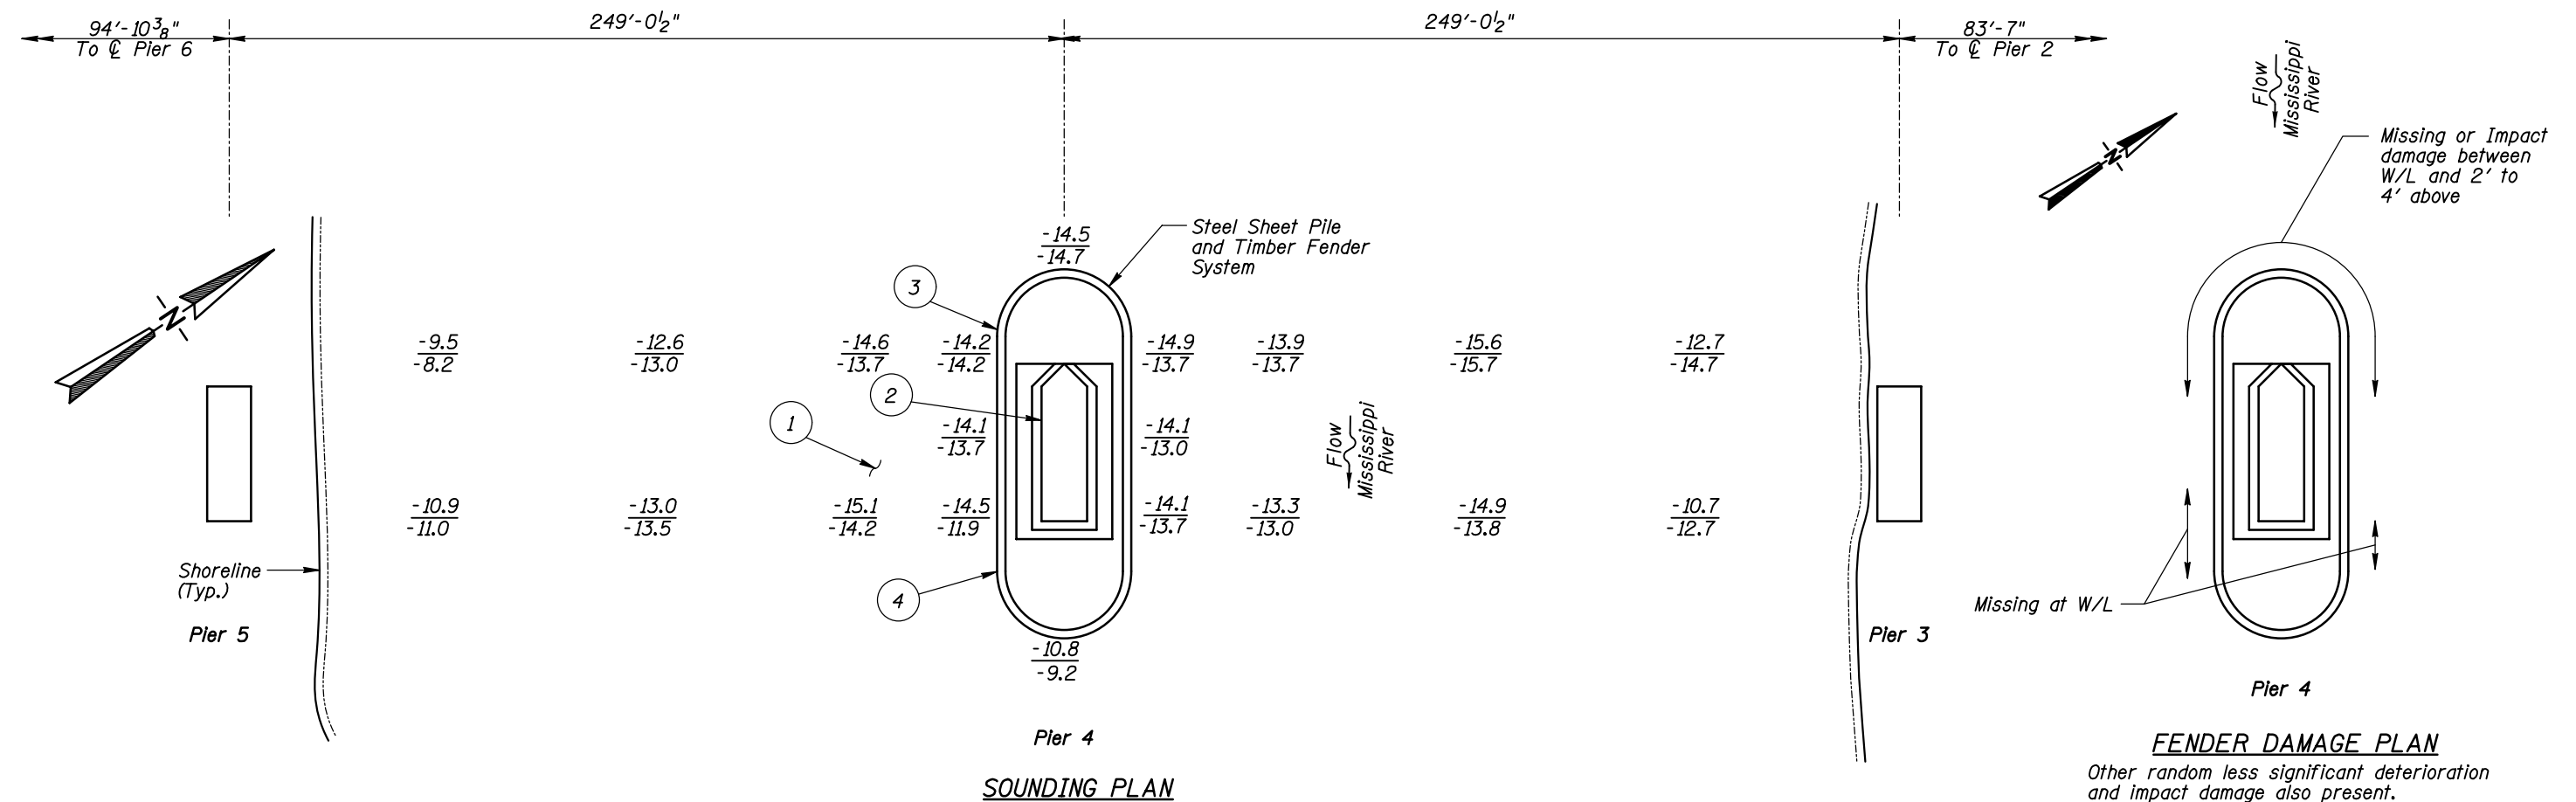
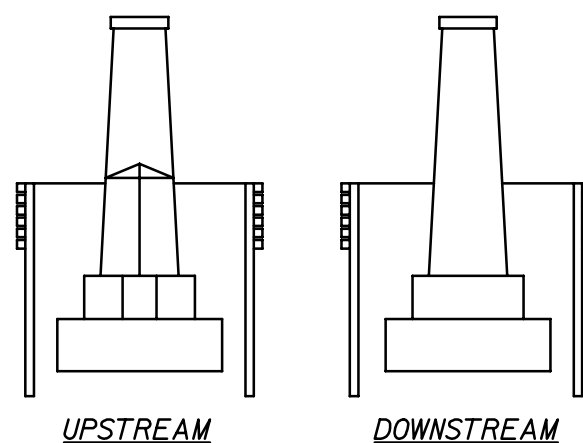
INSPECTION AND SOUNDING PLAN

- 1 The channel bottom material consisted of sand, gravel and areas of riprap, 3 feet diameter and smaller, with 2 inches of probe rod penetration.
- 2 The above water concrete was in satisfactory condition with random minor section loss having up to 2 inch penetrations, random map cracking with efflorescence and rust staining.

- 3 The steel sheeting encasing the concrete pier below water displayed a 1/8 inch layer of light to moderate corrosion, random 1 inch diameter rust nodules, and random 1/8 inch deep pitting.

- 5 The channel bottom material at downstream half of west side of pier 4 consisted of a sand layer on top of riprap with 2 inches of probe rod penetration.
